BERHAMPORE KINDERGARTEN, WELLINGTON

Conservation Plan

MHST 522 Historic Heritage Conservation

Victoria University of Wellington

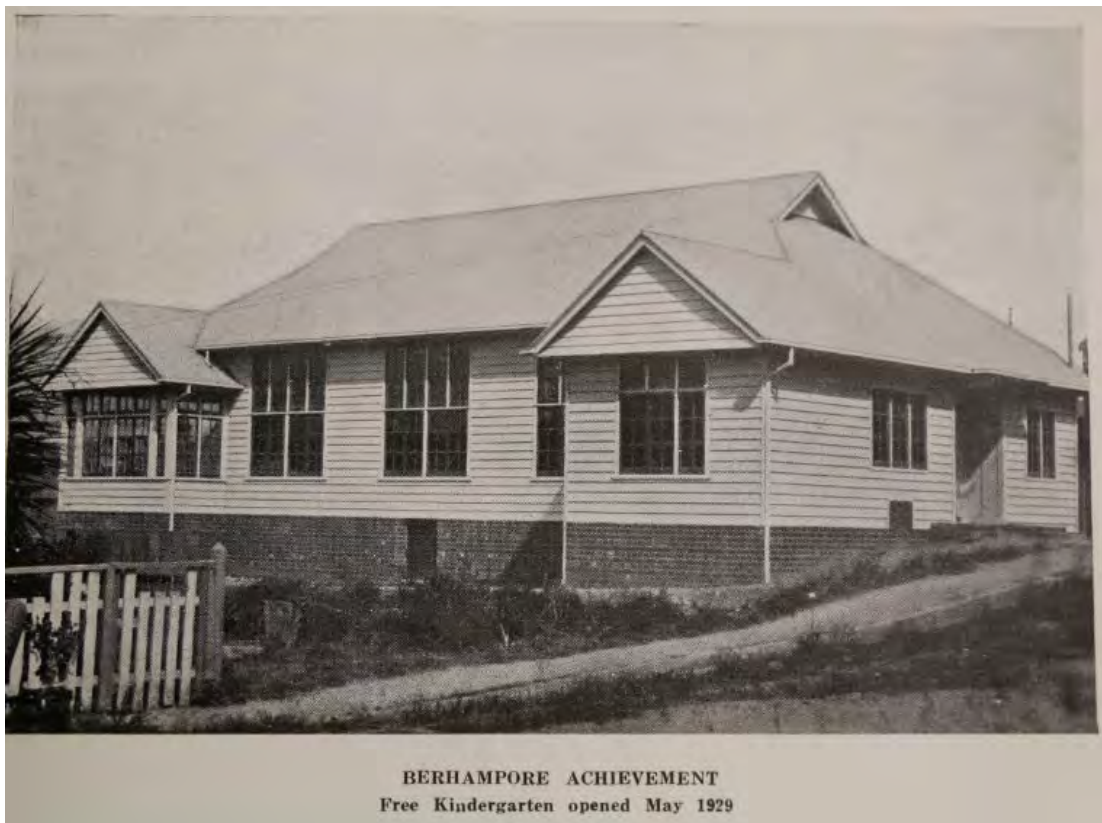
Figure 8: Berhampore Kindergarten in the year it opened, 1929. Photographer unidentified. Source: Wellington Free Kindergarten Association's *Report for the Year Ended 31st March 1929* (ATL MS-Papers-4105-10).

Opening on 27 February 1929, Berhampore Kindergarten was the first purpose-built kindergarten constructed in Wellington.⁴¹ The building had a frontage of 23.8 metres by a depth of 34.1 metres, a floor area of 166 square metres, and was a timber framing (*rimu*) on concrete and brick foundations.⁴² The exterior featured an unpainted corrugated iron roof, a chimney finished in cement stucco and decorated with shingle tiles, and redwood weatherboards on all exterior walls down to a brick base. The casement windows were of totara with sashes of redwood and the exterior doors were of redwood. The verandah on the north-east corner featured tongue and groove lining, and small mould finishing on the ceiling.⁴³

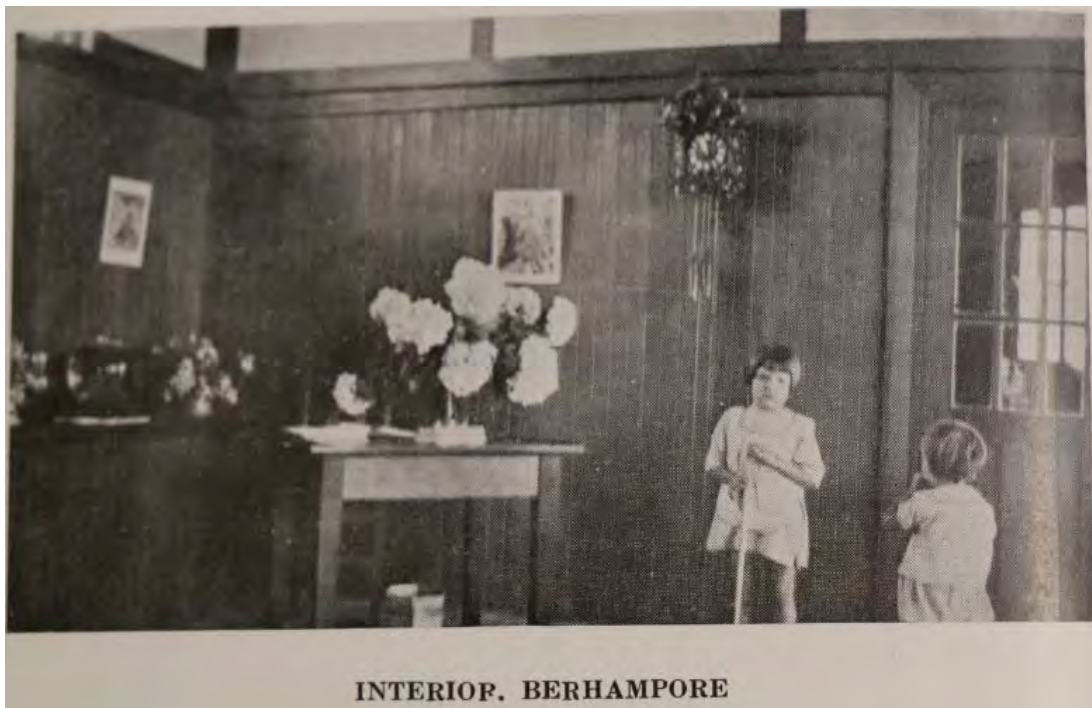
Figure 9: The interior of Berhampore Kindergarten, 1929. Photographer unidentified. Source: Wellington Free Kindergarten Association, *Report for the Year Ended 31st March 1929* (ATL MS-Papers-4105-10).

Inside, the kindergarten featured a main room with a high beamed ceiling, casement windows along the northern elevation, and a large brick fireplace that was pointed in white cement, decorated with shingle tiles, and had a cement hearth with nine inch fender walls. The tongue and groove floorboards were matai, some interior walls featured tongue and groove lining, and the interior doors were of rimu. The bathroom was painted but elsewhere woodwork was oiled and stained. Two panelled doors with glazed upper panels opened into the kindergarten from the hall. There was a service hatch between the kitchenette and main room, and other built-in features included a folding table in the kitchenette and window seats with storage underneath.⁴⁴ The building was praised for its light, airy spaces, and cross ventilation at the time of its opening, but the playground was not to be completed until sometime later.⁴⁵ The room to be used for the youngest group, the Babies' Room, was built by legacies left by Miss Anne Greenwood and Miss Sylvia Stowe. Other donations included furniture, a cuckoo clock, and a tea urn.⁴⁶

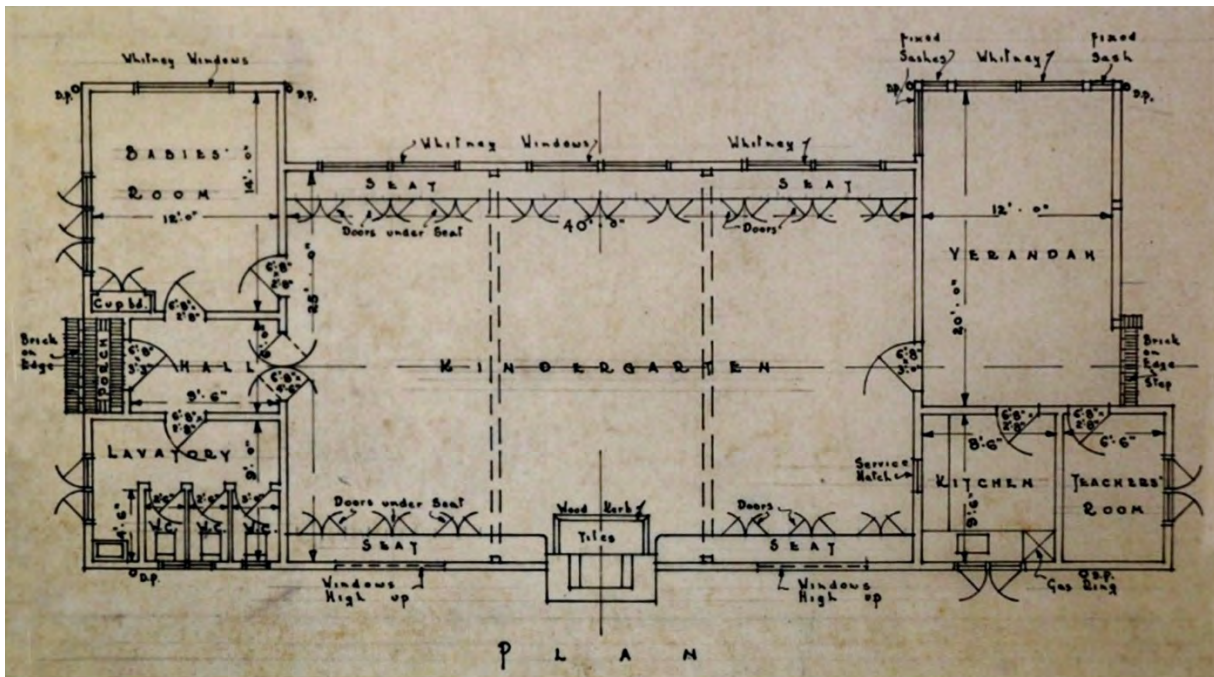
Figure 10: Original plan for Berhampore Kindergarten, 1927. Source: Gray Young Collection, Alexander Turnbull Library.

Plans for the new building were drawn up by Gray Young, Morton & Young, and H. G. Field's tender of £1497 for constructing the building was accepted in 1927.³⁸ The Department of Education granted £900 towards costs and the local committee raised additional money. Building work, however, was delayed because Wellington City Council wanted to use the land for an extension to the tramway system.³⁹ The foundation stone was eventually laid on 28 September 1928 by Lady Alice Fergusson, an event attended by kindergarten workers, friends of the movement, the Minister of Education the Hon. R. A. Wright, and Mary Richmond.⁴⁰

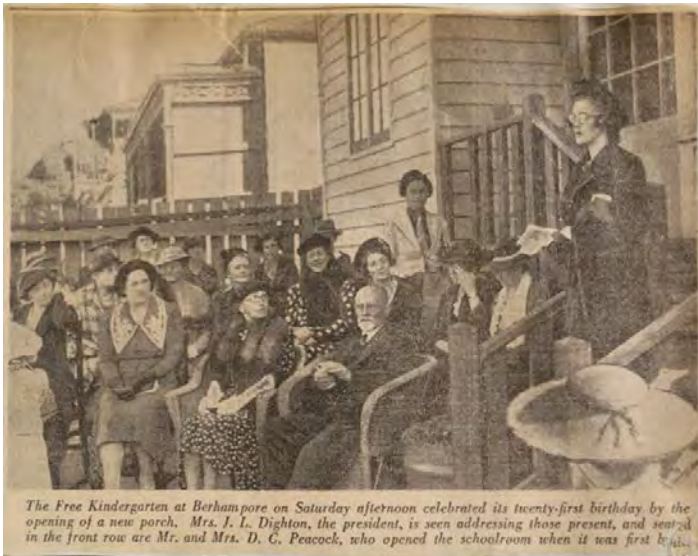
Figure 11: The opening of Berhampore Kindergarten's sun porch, 1938. Source: *Evening Post*, 29 March 1938 (ATL MSY-1922)

In 1928, the Kindergarten celebrated its 21st birthday with a birthday party, during which a sun porch was officially opened by Mr D. C. Peacock. The porch had been glassed in earlier that year using funds raised by the Local Committee and the Mothers' Club to commemorate the occasion.⁴⁷ This was the first of a number of modifications made to the building, some of which were made to coincide with key dates in the history of the kindergarten, such as anniversaries.

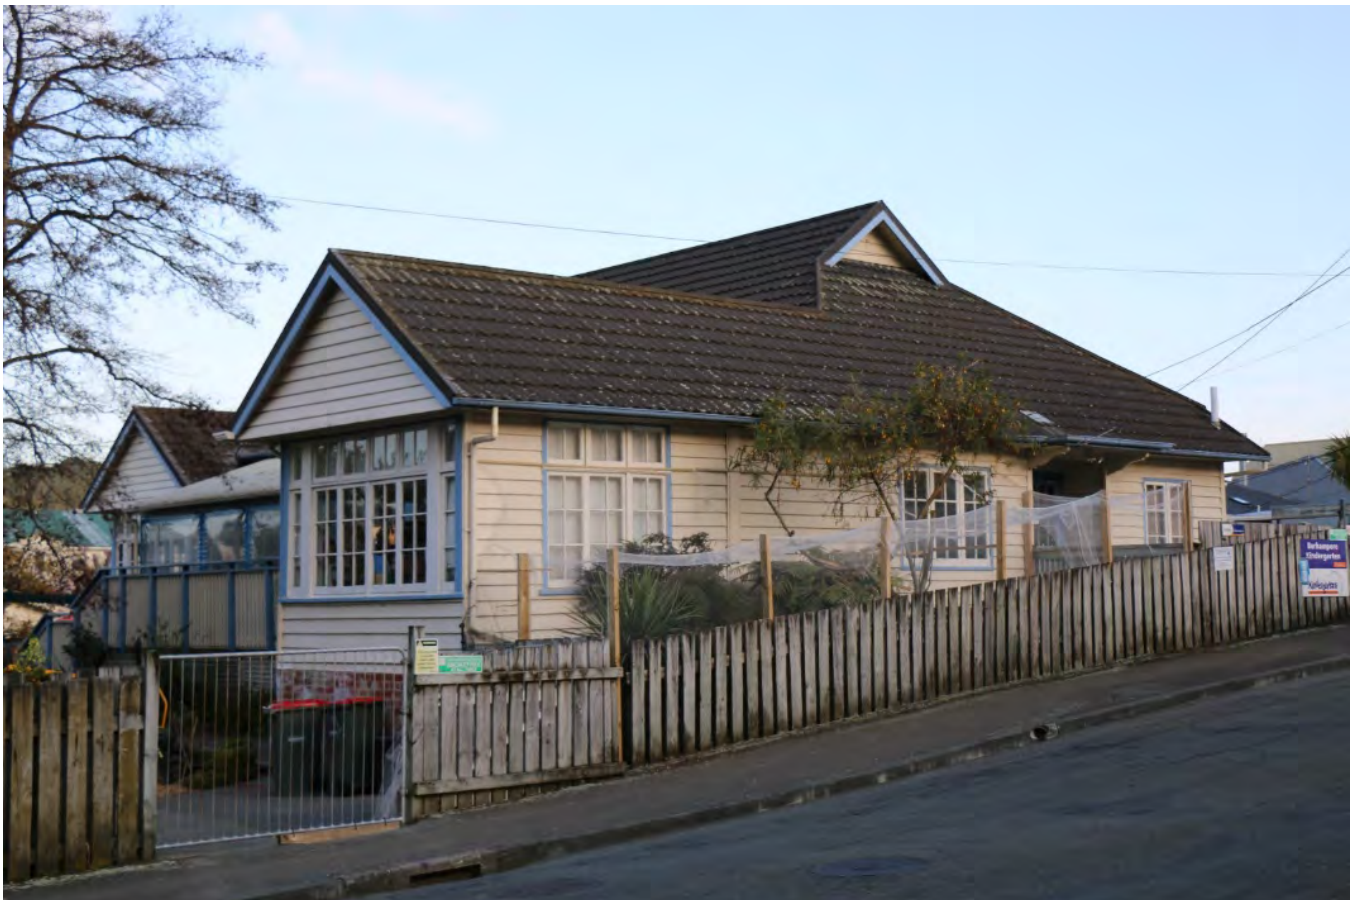
West elevation

Overall rank – 2

Element	Fabric	Rank
Cladding	Bevel back timber weatherboards, corner boards, bargeboards	2
Spouting	PVC gutters and downpipes	0
Deck	Timber decking and balustrade	0
Foundation stone	Marble	2
Foundation wall	Brick and mortar	2
Porch roof	Timber including corbels	2
Doors	Timber, each with nine lights	0
Windows	Timber casement windows with nine lights; fanlights with two lights; timber sills and scribes	2

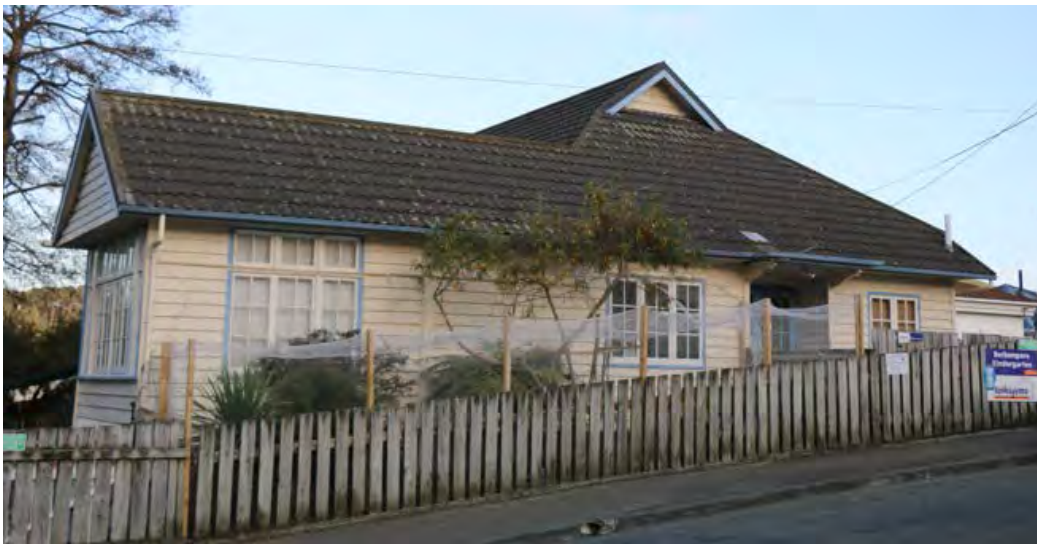
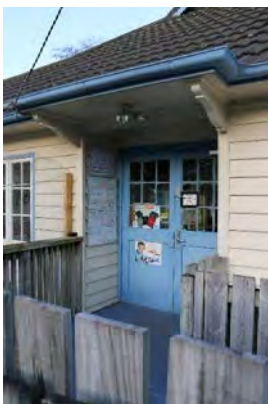
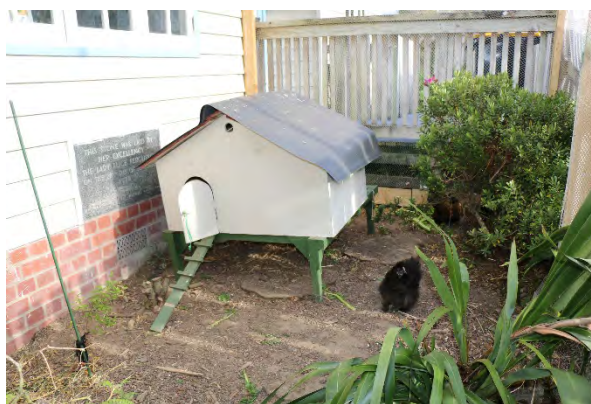
North elevation

Overall rank – 2

Element	Fabric	Rank
Cladding	Bevel back timber weatherboards, corner boards, bargeboards	2
Spouting	PVC gutters and downpipes	0
Verandah	Timber balustrade, steps and decking; corrugated acrylic; PVC	0
Foundation wall	Brick and mortar	2
Door	Timber with eight lights; brass letterbox	2
Doors	Timber bi-fold with eight lights	0
Doors	Tongue and groove timber doors in foundation wall	1
Windows	Mullioned windows with four lights (not original)	0
Windows	Timber casement windows with three or nine lights; fanlights with one or two lights; original mullioned windows with four lights; timber sills and scribes	2

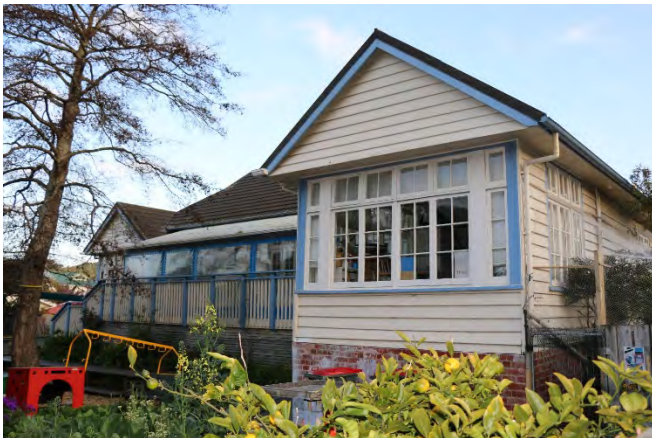
East elevation

Overall rank – 2

Element	Fabric	Rank
Cladding	Bevel back timber weatherboards, corner boards, bargeboards	2
Spouting	PVC gutters and downpipes	0
Foundation wall	Brick wall and mortar	2
Foundations	Timber, wire netting	0
Steps	Timber balustrade, steps and decking	0
Door	Timber sliding door with twelve lights	2
Windows	Timber casement windows with nine lights; fanlights with two lights; mullioned window with four lights; timber sills and scribes	2

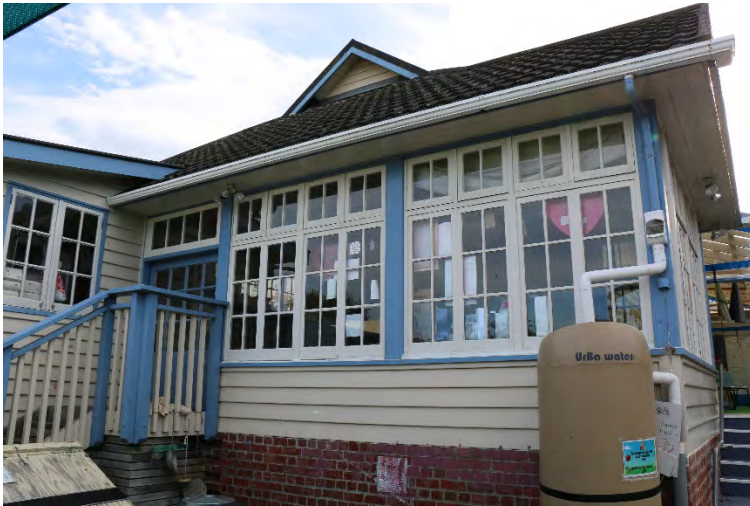
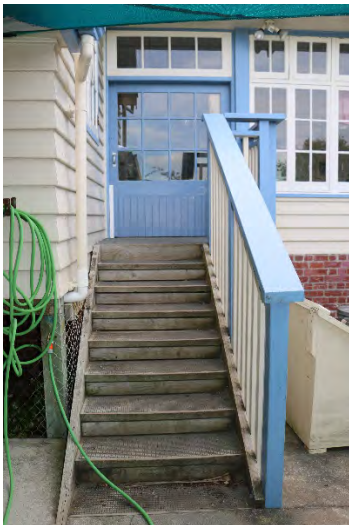
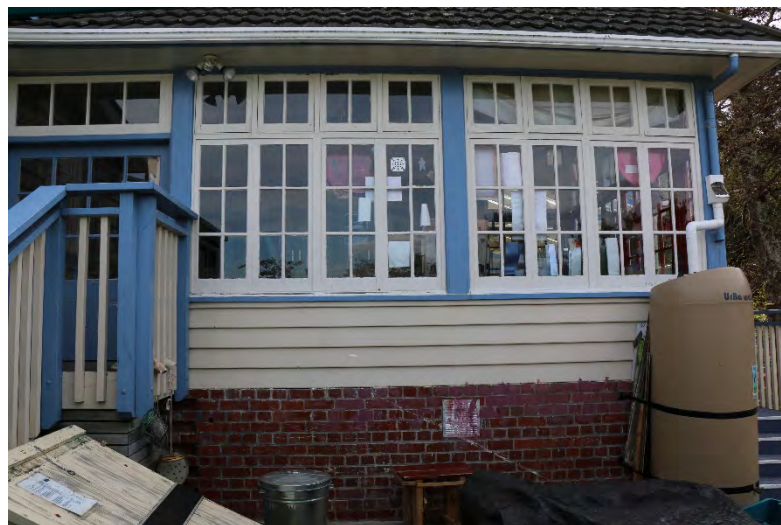
South Elevation

Overall rank – 2

Element	Fabric	Rank
Cladding	Bevel back timber weatherboards, corner boards	2
Spouting	Gutters and downpipes (PVC)	0
Spouting	Downpipes (metal)	2
Foundation wall	Brick and mortar	2
Chimney	Plastered with shingle tiles, metal trim	1
Windows	Timber casement with one or four lights; timber sills and scribes	2

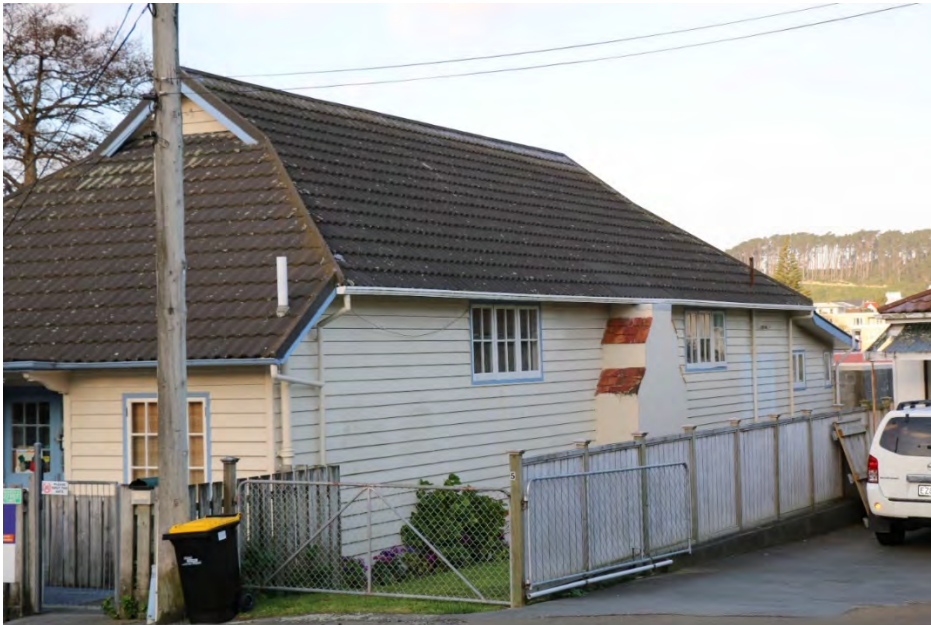
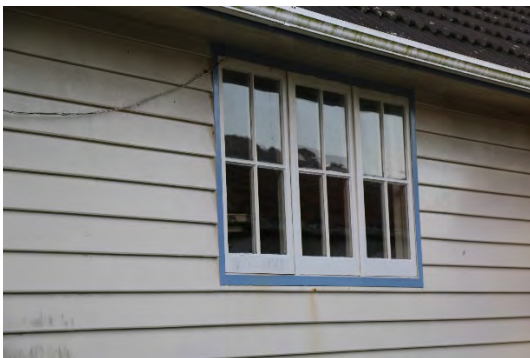
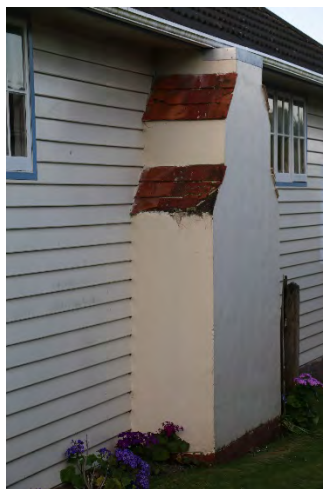
Sub-floor and foundations

Overall rank – 2

Element	Fabric	Rank
Piles	Concrete, timber	2
Foundation wall	Brick and mortar	2
Bearers	Timber	2
Floor joists	Timber	2
Retaining wall	Timber	0

Subsidence has been caused by deterioration in the ground. The solution would need engineering input and is likely to include repair to the foundation wall and some form of ground stabilisation, for instance, piling or concrete foundations.

The main part of the building requiring stabilisation is the foundation wall on the northwest corner, which shows evidence of subsidence.
